GENERAL MITCHELL INTERNATIONAL AIRPORT

RUNWAYS 1L-19R AND 7R-25L INTERSECTION PAVEMENT STUDY FINAL REPORT

Project No. A135-08017

Michael Baker Jr., Inc.
Moon Township, Pennsylvania

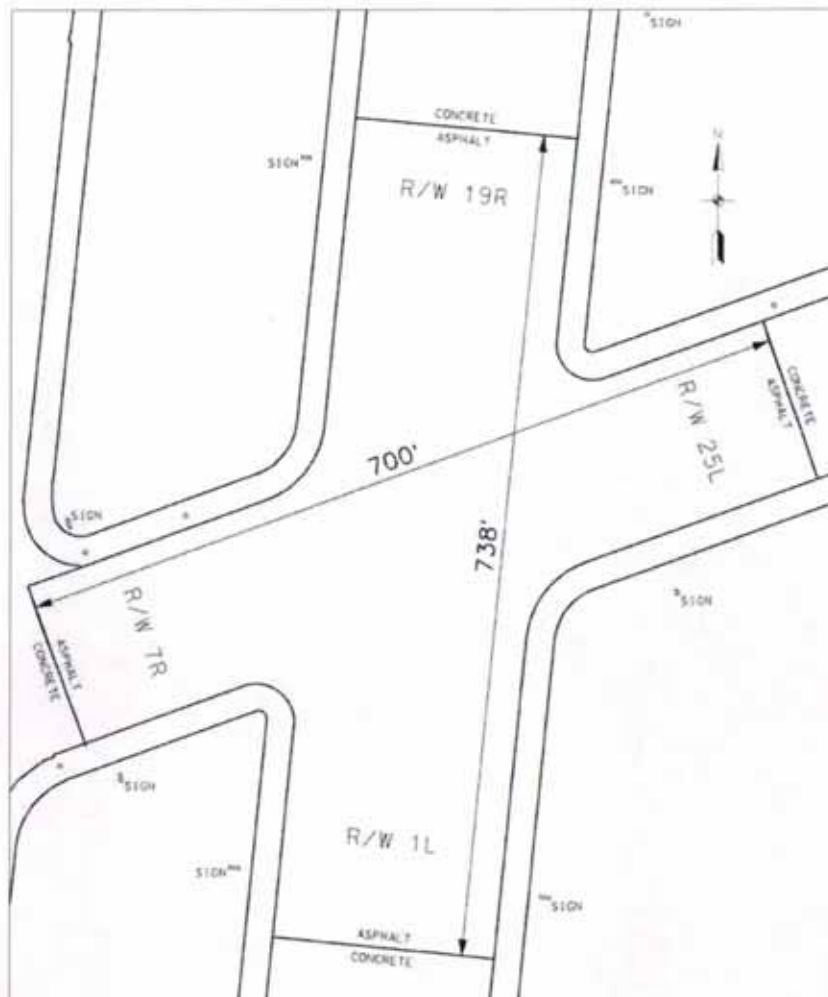
**FIGURE 2.2**

This study consists of a detailed evaluation of the existing pavement within the intersection of the two primary runways used for daily operations, Runways 1L-19R and 7R-25L, in order to determine the best approach for pavement rehabilitation. The intersection consists of hot mix asphalt (HMA) pavement and its limits are physically defined by its termination at the Portland cement concrete (PCC) pavement portions of each runway. It is approximately 738 feet long along Runway 1L-19R and approximately 700 feet along Runway 7R-25L, as shown in Figure 2.2 below.

The area within this boundary has been repaired on a yearly basis by milling and overlaying various patch locations with approximately four inches of surface course. Yearly costs have been approximately \$100,000, with the exception of 2008 in which approximately \$300,000 was spent. The existing pavement continues to deteriorate and requires this yearly repair that has become extremely difficult to perform due to operational considerations mentioned above.

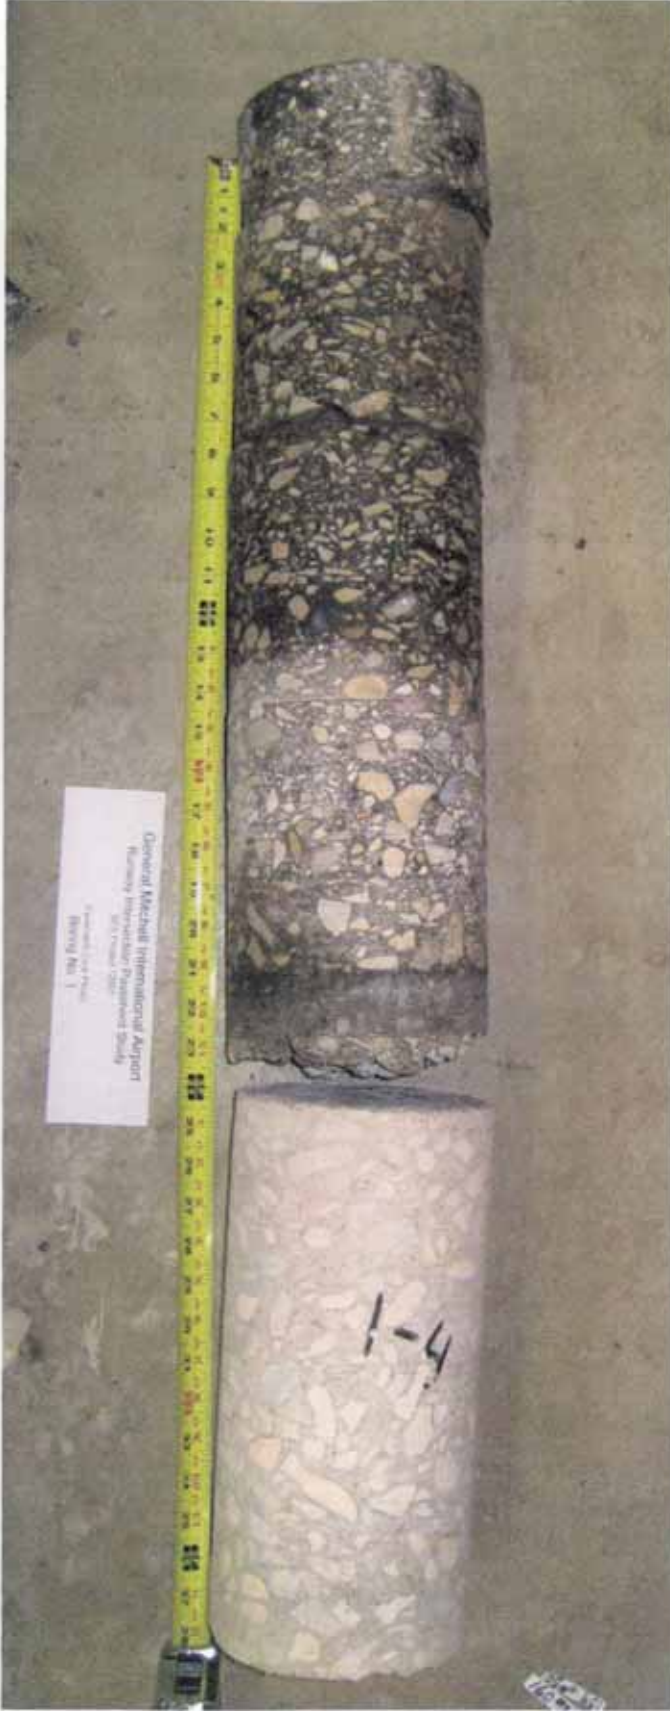
BORING 1

Core No.	Thickness, in			Remarks
	Asphalt	Concrete	AGBS	
<i>RW 1L-19R</i>				
1	22.6	13.0	8.4	Delaminated at 3" and 9". Moisture present down to 4"
2	26.6	12.0	15.4	Delaminated at 22". Disintegration present at 5". Moisture present throughout core.
3	23.0	12.0	9.0	Disintegration present at 6". Moisture present from 2" to the bottom.
4	19.8	11.1		Delaminated at 4", 8" and 13". Loose aggregate at 8". Moisture present down to 15".
5	19.9	11.3		Delaminated at 6", 16" and 19". Moisture present between 16" to 22"
6	20.0	12.5	12.0	Delaminated at 17".
7	19.6	12.3	12.1	Delaminated at 2" and 9". Moisture present between 2" and 9".
<i>RW7R-25L</i>				
8	20.3	12.8		Delaminated at 3" and 6". Moisture retention at the bottom
9	15.3	12.0		Delaminated at 7". Moisture present throughout core.
10	13.3	13.0	8.8	Delaminated at 8".

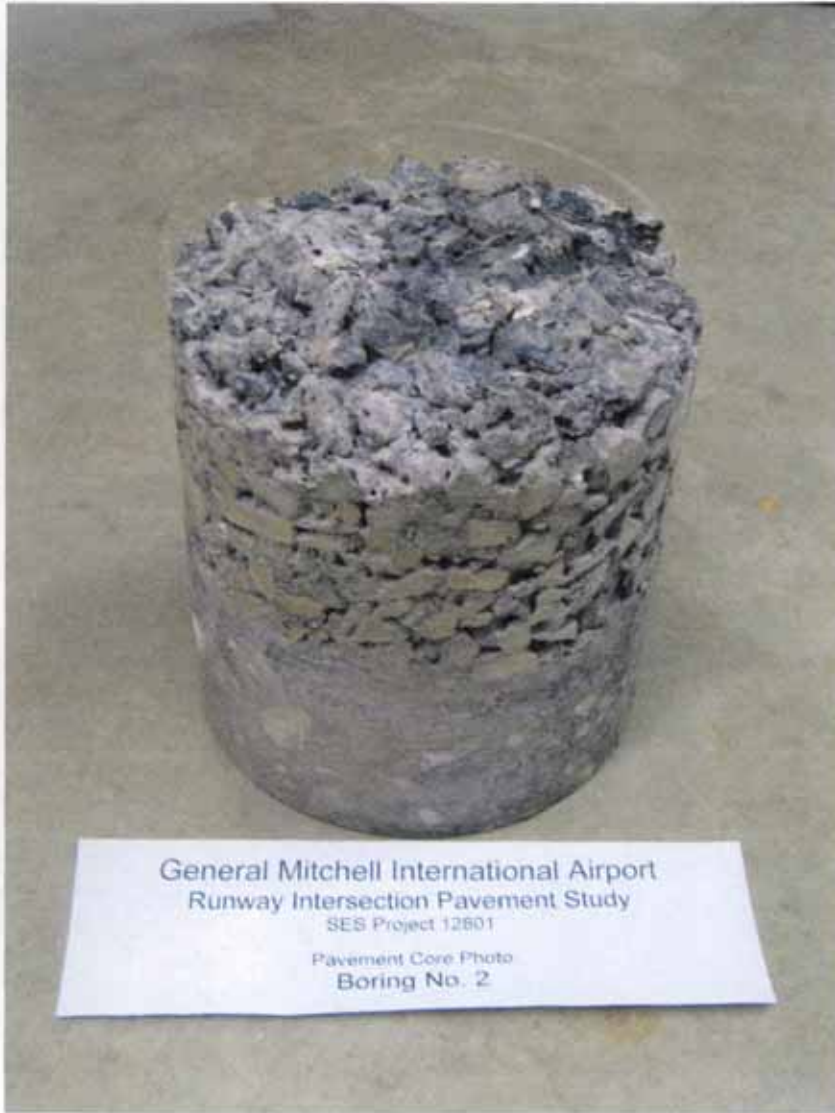
BORING 2
(Detail of bottom of asphalt portion of core)

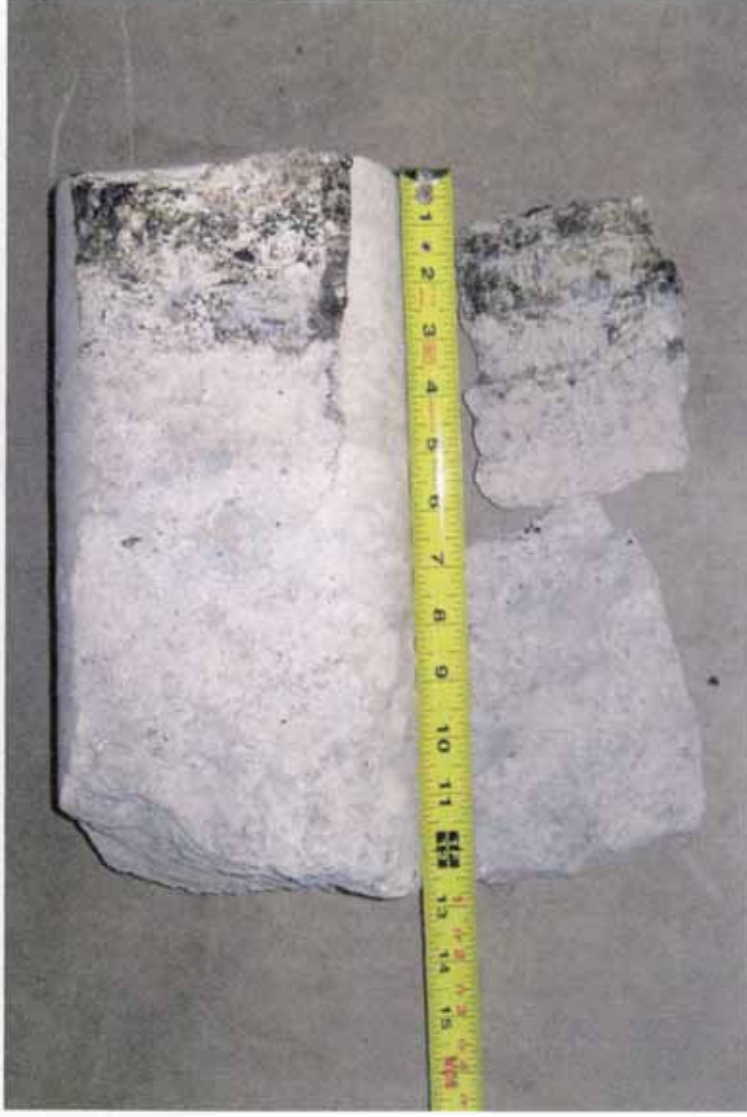
BORING 6

(Detail of Filled Fracture at Top of Concrete Pavement)

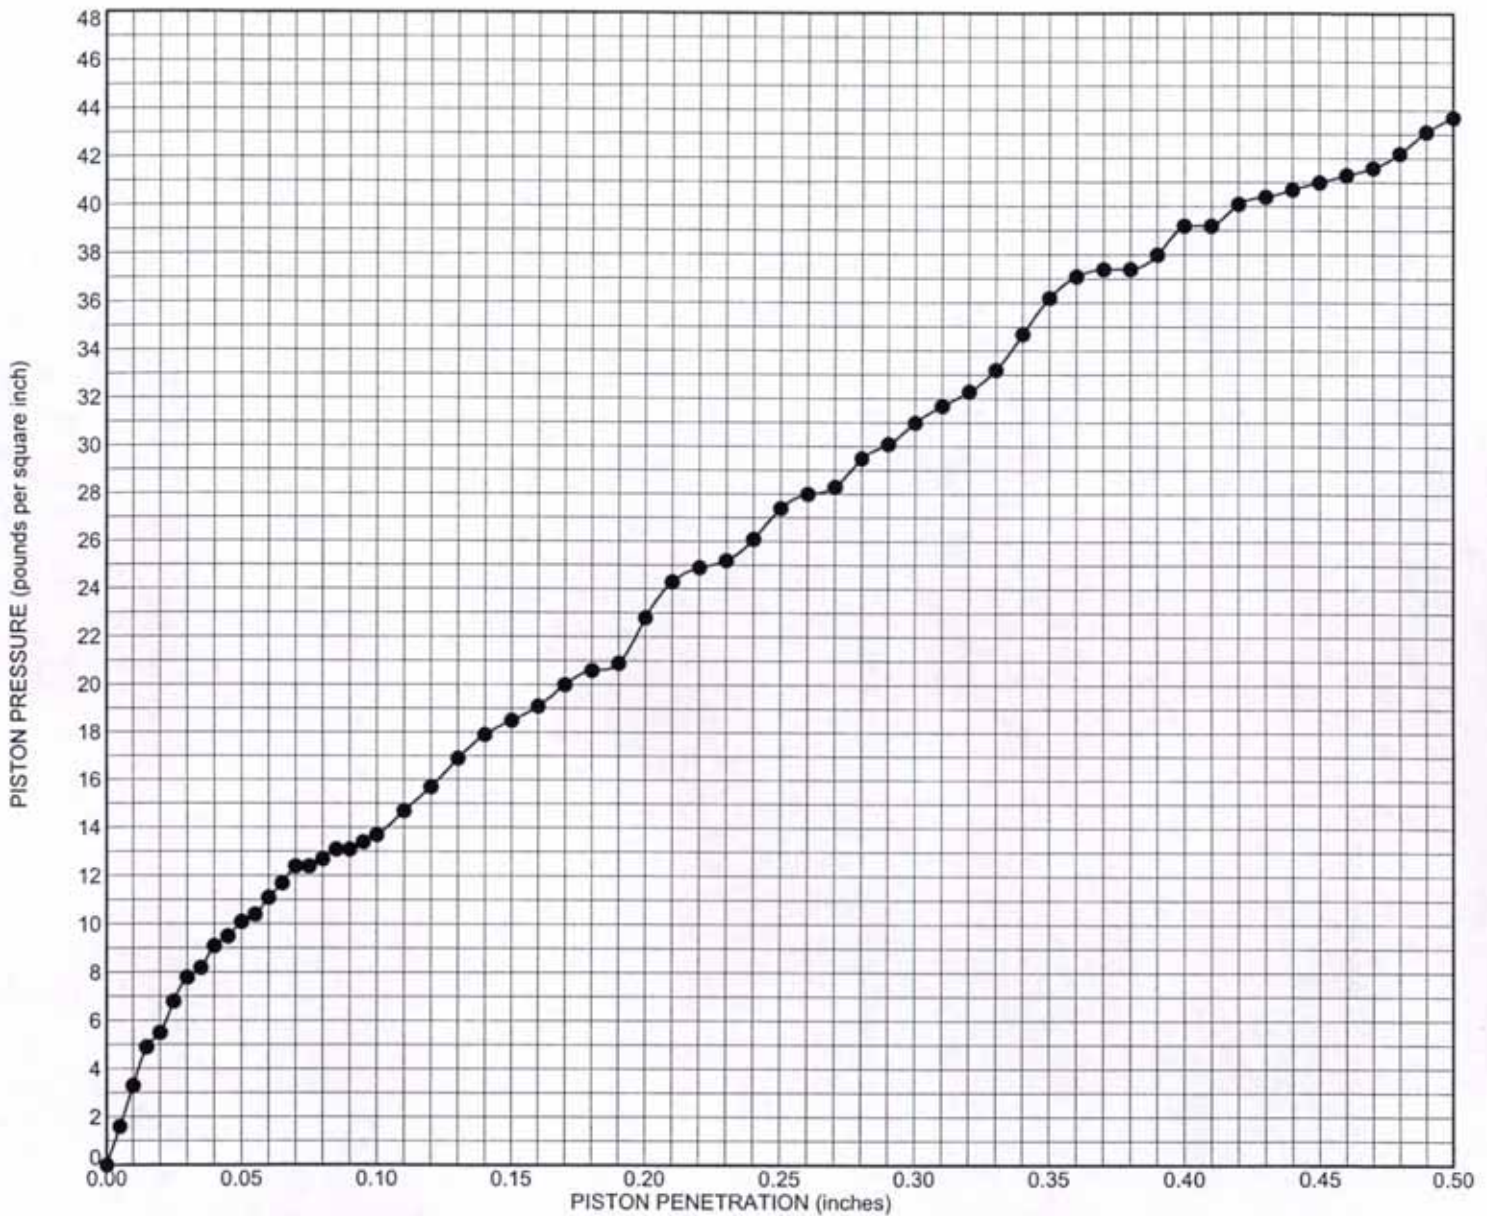
CALIFORNIA BEARING RATIO TEST REPORT

ASTM Test Designation D1883
Piston Pressure Versus Piston Penetration

Penetration (inches)	Piston Pressure (psi)	Conversion Pressure (psi)	CBR Value (%)
0.100	13.7	1000	1
0.200	22.8	1500	2
0.300	31.0	1900	2
0.400	39.2	2300	2
0.500	43.7	2600	2

Miscellaneous Information	
Method Of Compaction:	ASTM D1557 Method A
Surcharge Weight:	105 lb
Blows per layer:	10
Sample was soaked for:	101 hours which yielded a 0.7% swell from the initial sample height.

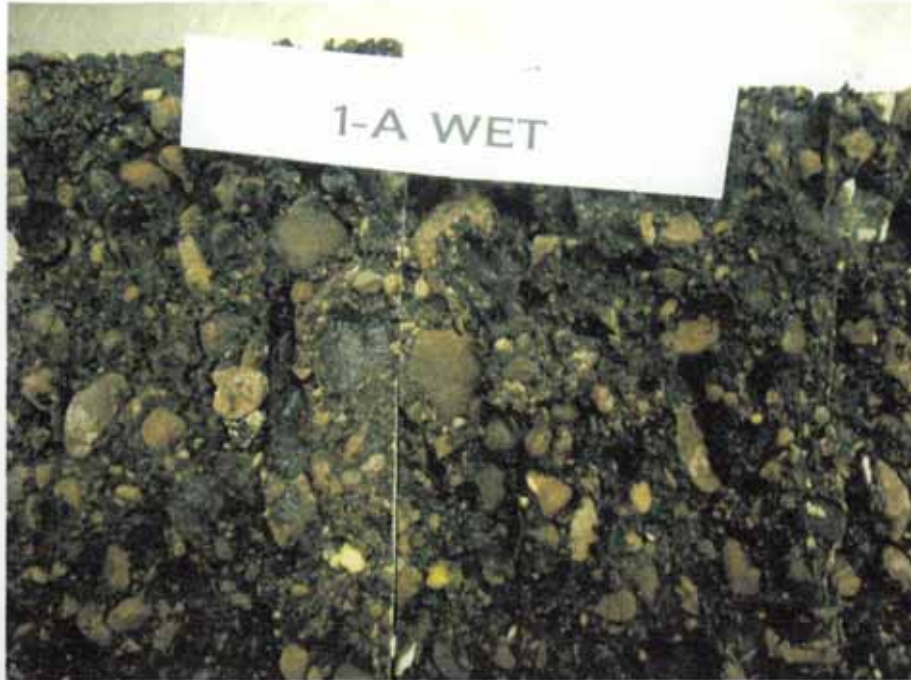
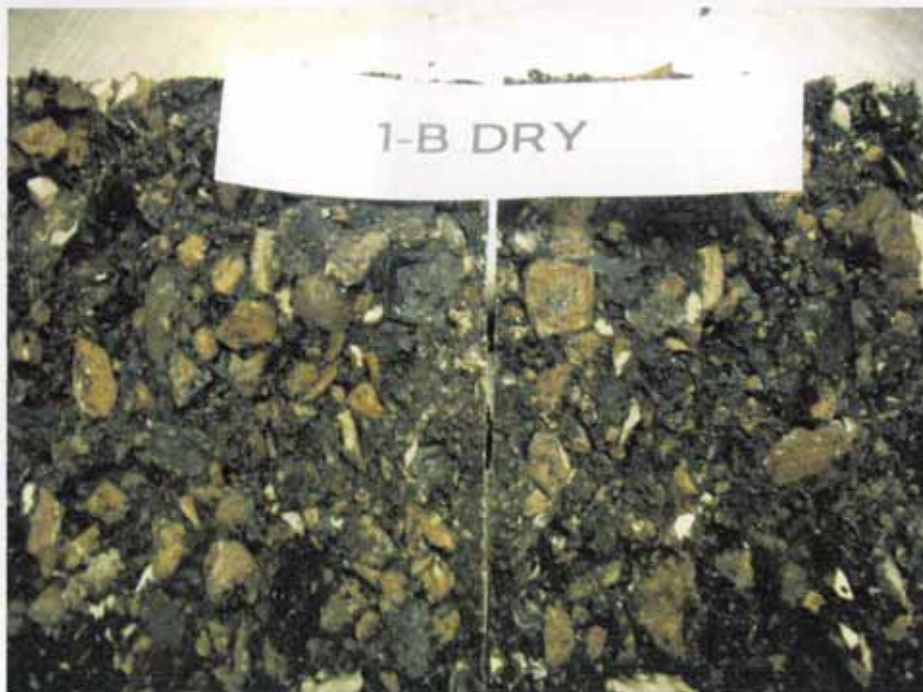
BORING 1 TSR Sample

Specimen Inspection				
Moisture Damage				
Broken Aggregate

Moisture susceptibility in HMA is evaluated using the TSR. The test standard followed is "AASHTO T283, *Resistance of Compacted Bituminous Mixtures to Moisture Induced Damage*". This test basically measures the tensile strength in a dry sample and compares it to the tensile strength of a partially saturated sample. The percent air voids (Va) for both the dry and saturated samples should be between 7 +/-1 percent for all new mixes. When testing existing pavements, air void contents for comparison samples should also be similar. The ratio developed between the saturated and dry samples should be above 0.8 for new mixes and above 0.7 for the existing materials. Table 3.4 "Tensile Strength Results" show the results obtained from MTE Services, Inc. When reviewing the results, it should be noted that the air void contents for the dry and saturated samples for each core have wide variations. This variation may be due to testing different HMA layers and or mix types within the same core or the lack of compaction between the same layers. Core 7 was the closest to the prescribed air void content of +/-1 percent with a variation of 2.5 percent. Given the TSR result of 0.67, the material found within the core may be susceptible to moisture damage. In either case, cores 1 and 3 have an air void content variation greater than 5 percent and the TSR results do not provide conclusive evidence. As such, only the very low dry tensile strength results could be reviewed. Low tensile strength results are typical in HMA mixtures that have low asphalt and or high air void contents. As stated above, these types of results are indicative of HMA mixes that are considered permeable and will allow for moisture induced damage, such as stripping to occur.

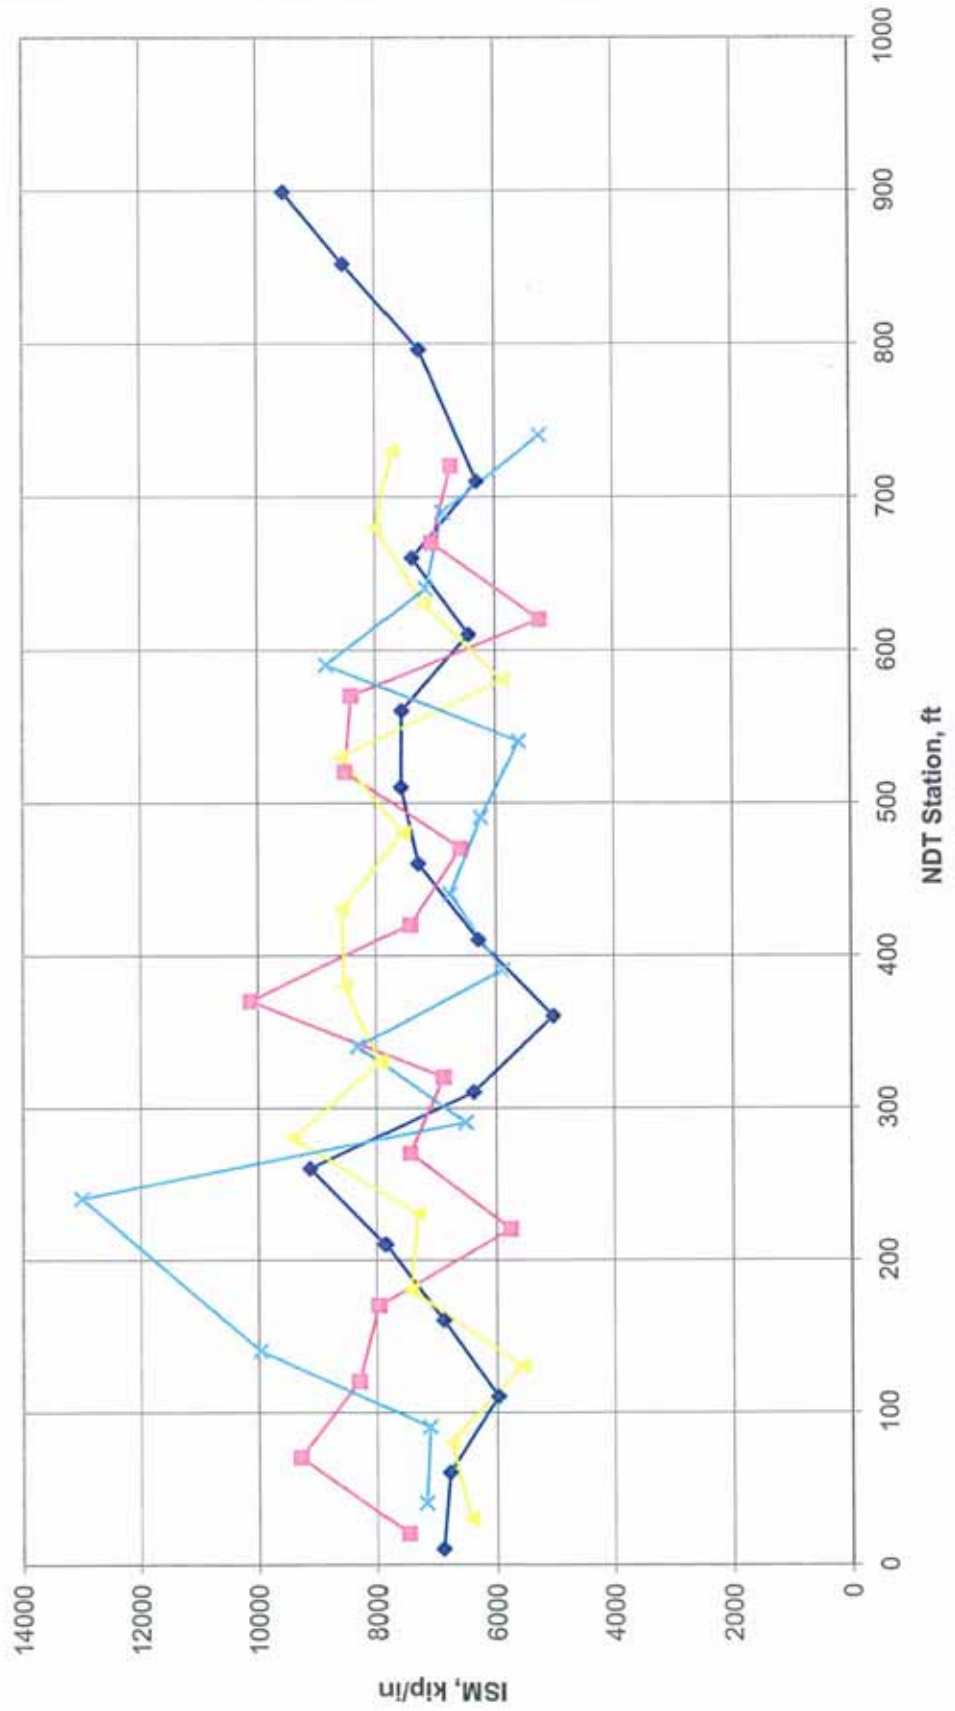
ISM Plot for RW 1L-19R

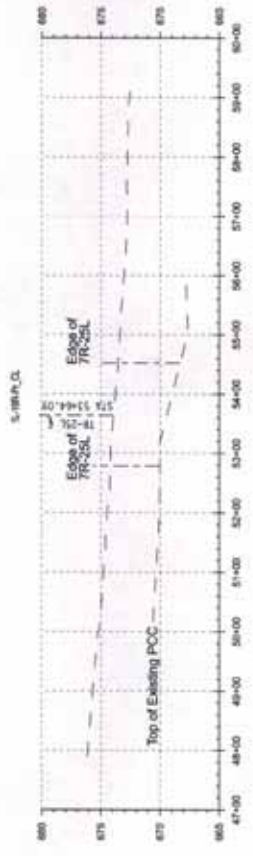
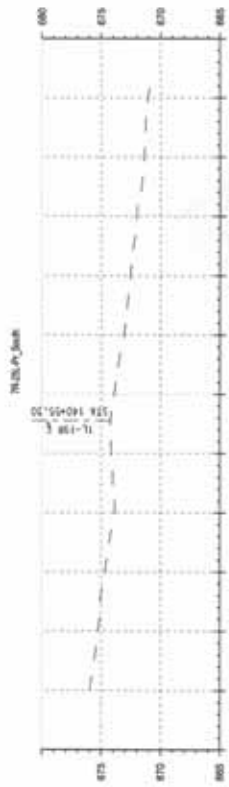
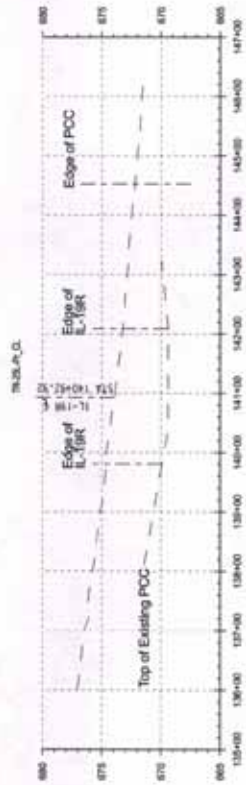
Typical Sections

16" PCC
2" Bituminous Leveling Course
Bituminous Concrete, Depth Varies
12" Existing PCC
12" Existing Aggregate Subbase

Regardless of which alternative is selected, it is recommended that the areas of existing bituminous pavement outside of the 200-foot runway safety area should be replaced with 16-inches of PCC on top of a 2-inch HMA leveling course which will be constructed on top of the

The PCC alternative was designed using a composite k value of 213 pci. The existing PCC and HMA below the proposed section will be left in place. Given the variable thickness of HMA above, removal of portions of the existing PCC will be required. As such, the existing PCC has been evaluated as a high quality aggregate material for the pavement design. After removal of the existing pavement structure has been made to the prescribed depth an HMA leveling course with a minimum thickness of 2-inches is recommended prior to the placement of the new PCC. It is further recommended that the new PCC thickness be 16-inches. A typical section of this alternative can be found in Appendix C.
